OPCW

S/1731/2019
1 March 2019
Original: ENGLISH

NOTE BY THE TECHNICAL SECRETARIAT

**REPORT OF THE FACT-FINDING MISSION REGARDING THE INCIDENT
OF ALLEGED USE OF TOXIC CHEMICALS AS A WEAPON
IN DOUMA, SYRIAN ARAB REPUBLIC, ON 7 APRIL 2018**

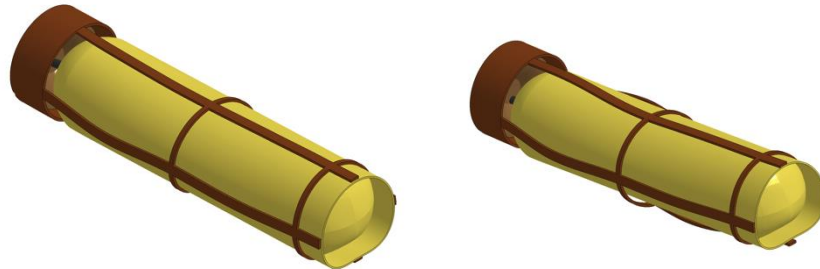
FIGURE 13: COMPUTER-MODULATED DAMAGE TO THE CYLINDER WHILE PASSING THROUGH THE ROOF

8.35 In a similar manner, the FFM assessed the consistency between the structural damage appearing on the cylinder against the structural damage to the rebar-reinforced

concrete roof through which the cylinder allegedly traversed. Results are presented in Figures 13 and 14.

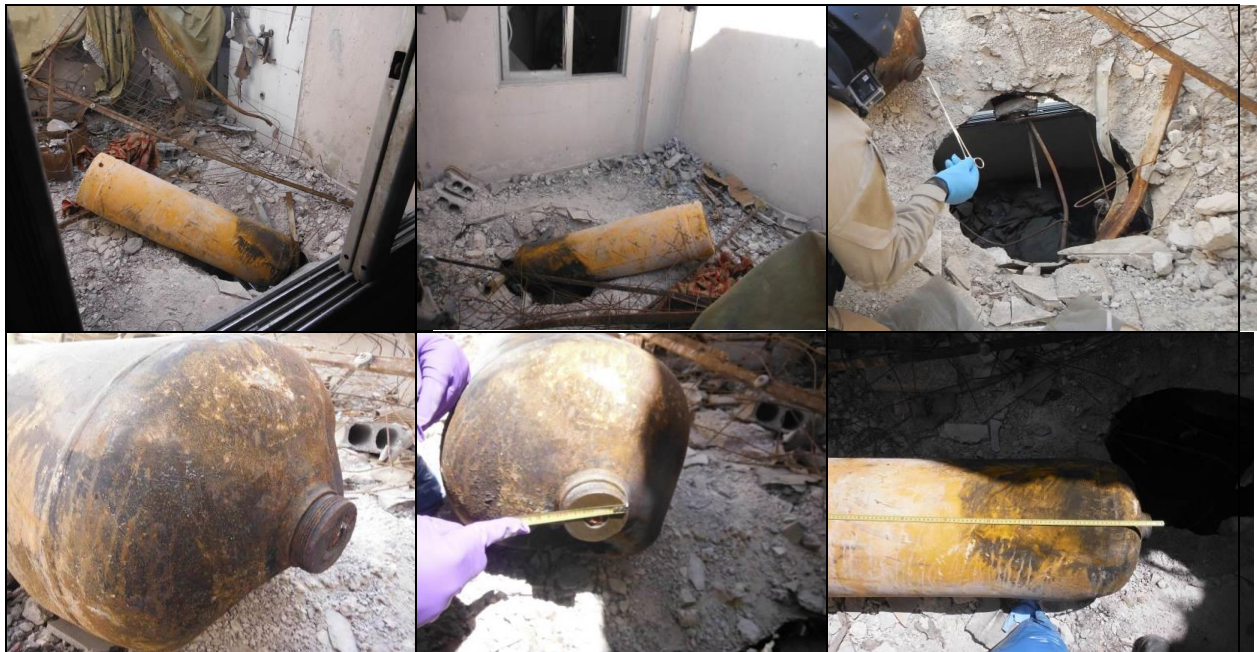
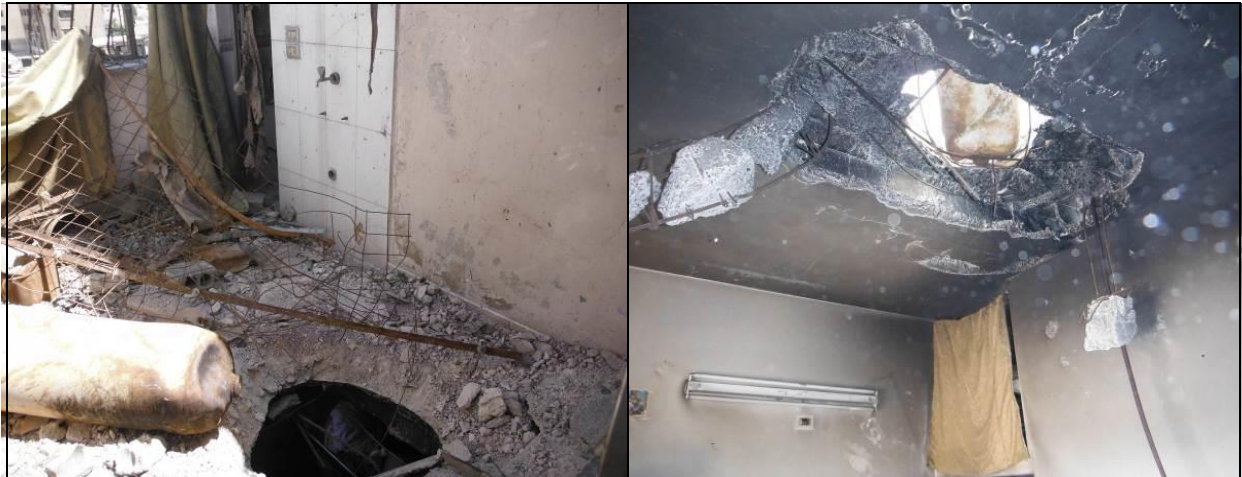
FIGURE A.6.1 PHOTOS OF TERRACE, CRATER, AND ROOM BENEATH

3. The aperture observed was circular in shape with approximately 45 degrees angular edges.
4. The mangled ironwork present on the patio indicated that there would have been a metallic frame and mesh covering it at one stage, though it was not clear whether this would have been present at the time of the alleged incident or had been demolished prior to that. The visual damage on the body of the cylinder indicates that the lateral aspect of the cylinder did not slide on the mesh but it hit perpendicularly.

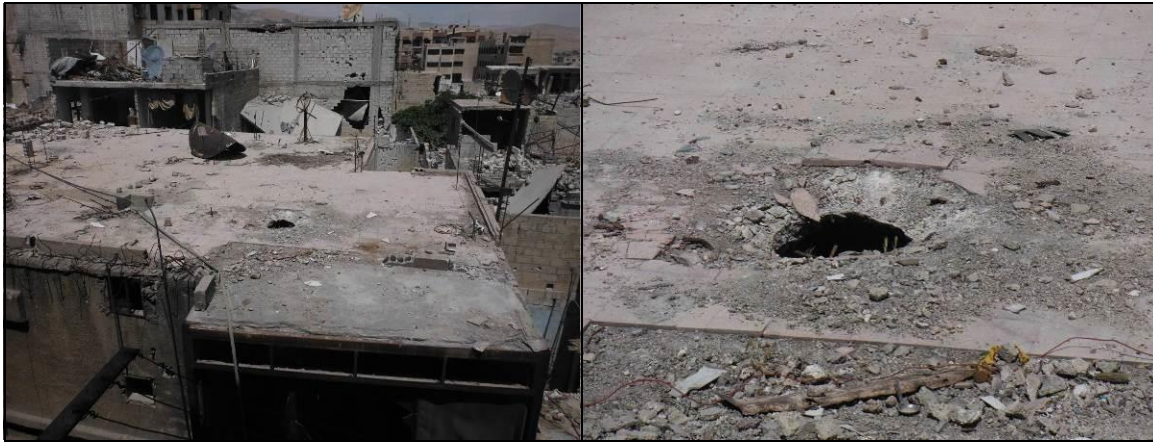
FIGURE A.6.3 ADJACENT ROOF SHOWING A CRATER SIMILAR TO THE ONE ON THE ROOF TERRACE AT LOCATION 2

5. The FFM team noted that a similar crater (see photos below) was present on a nearby building.

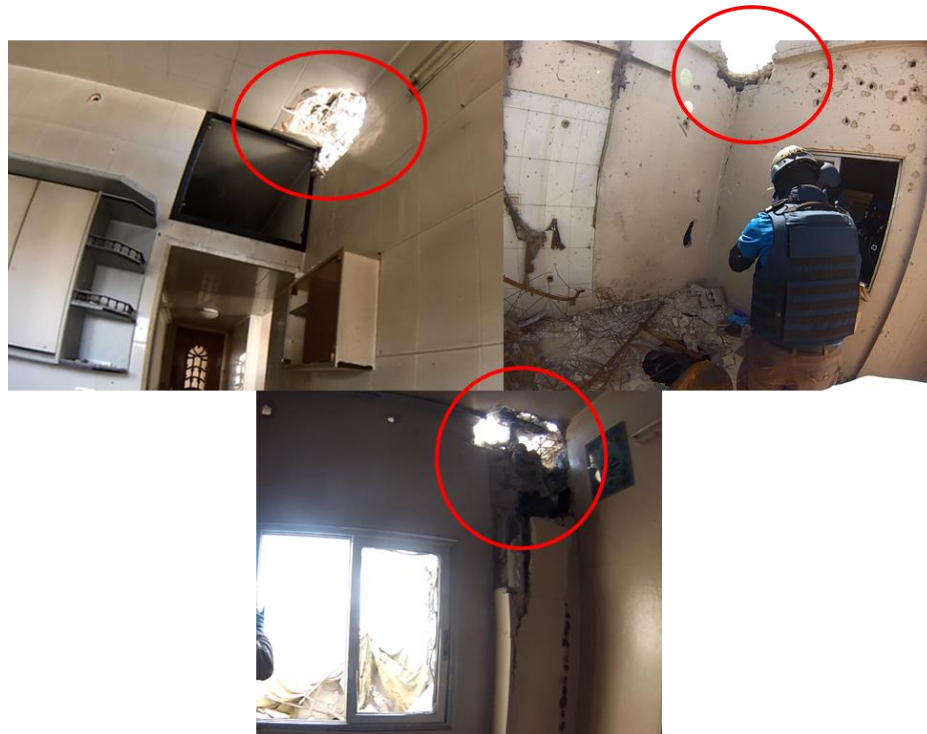
FIGURE A.6.4 DAMAGE ABOVE THE CRATER OBSERVED FROM DIFFERENT ANGLES

6. The team was not able to climb on to the top of the building due to the security restrictions, but was able to observe damage in the corner of the balcony location above the crater.

7. Observing the damage on the roof above the crater, the experts were able to provide an explanation of the cylinder not penetrating completely through the aperture. It can be seen that there was a large impact on the roof and walls above the balcony. The impact would decrease the velocity of the falling cylinder and changed its trajectory while hitting the concrete floor of the balcony causing a hole in it, but without sufficient energy to fall through it.

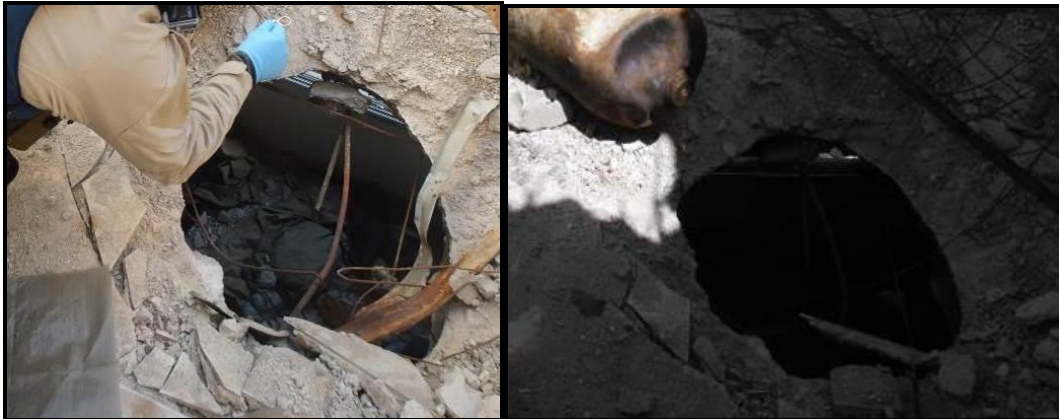
FIGURE A.6.8 CRATER AS SEEN BY FFM INSPECTORS

8. The FFM analysed the damage on the rooftop terrace and below the crater in order to determine if it had been created by an explosive device. However, this hypothesis is unlikely given the absence of primary and secondary fragmentation characteristic of an explosion that may have created the crater and the damage surrounding it.
9. The FFM team noted the blackening of the ceiling and the rim of the aperture from the room immediately below the point of impact (see photo above). It also noted the blackened sooty walls in the corner of the room, as well as what appeared to be the ashen remnants of a small fire. One interviewed witness stated that a fire had been lit in the room after the alleged incident, reportedly to detoxify it of the alleged chemical.

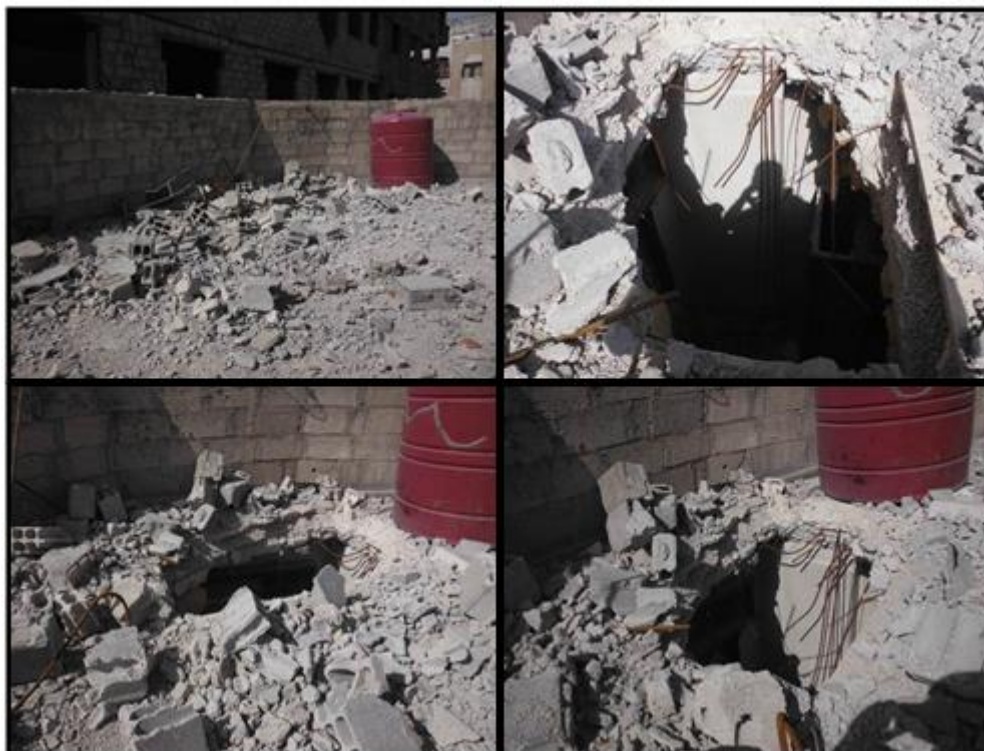
FIGURE A.7.4 CRATER ON THE ROOF OF LOCATION 4

The aperture was located close to a surrounding wall and next to the water tank with approximate dimensions of 166 x 105 cm. The distance from the adjacent building varies between 230 cm and 250 cm.

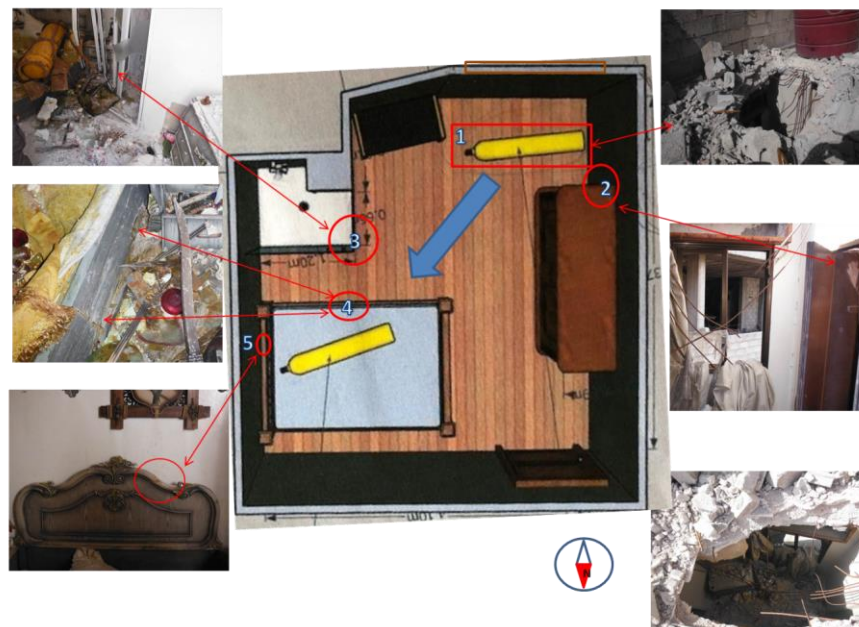
FIGURE A.7.7: POSSIBLE TRAJECTORY OF THE CYLINDER INSIDE THE ROOM

Considering the proximity of the water tank, the neighbouring buildings, and the surrounding wall adjacent to the hole in the roof, it was concluded that the cylinder impacted the roof as shown in Figure A.7.6. From the shape of the crater and damage on the cylinder, it is likely that the cylinder landed parallel to the ground creating a crater with dimensions of approximately 166 x 105 cm, which is in keeping with the dimensions of cylinder of 140 x 35 cm. It should be noted that the cylinder had an additional structure attached to the body, which is still in line with the dimensions of the crater. The damage observed on site by the FFM team and the possible trajectory of the cylinder based on observed damage and numerical calculations are represented in Figure A.7.7.

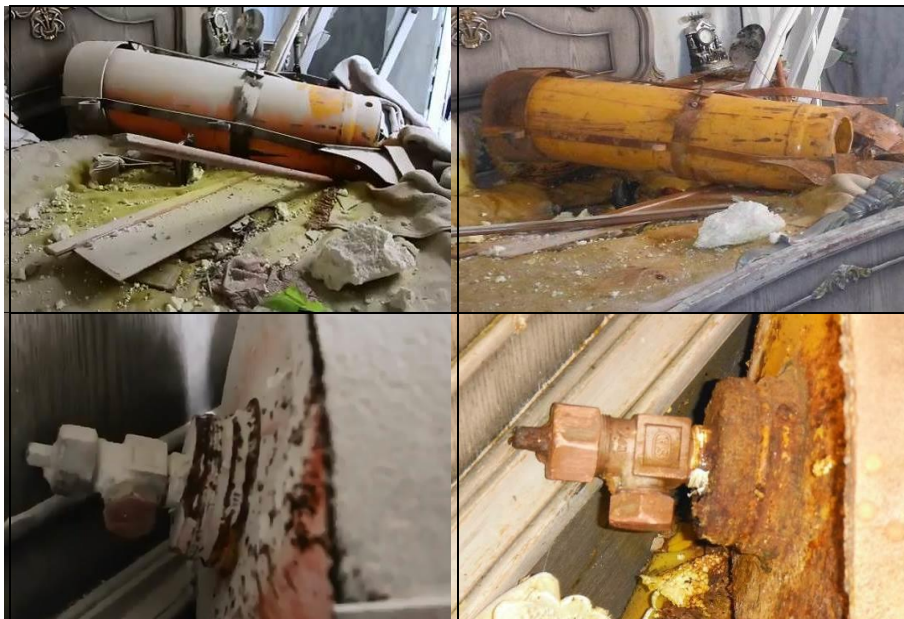
FIGURE A.7.8 CHANGES IN THE SCENE

- The cylinder appears to have been cleaned. The layer of a white powder seen in the videos was not present when the FFM team visited the location.

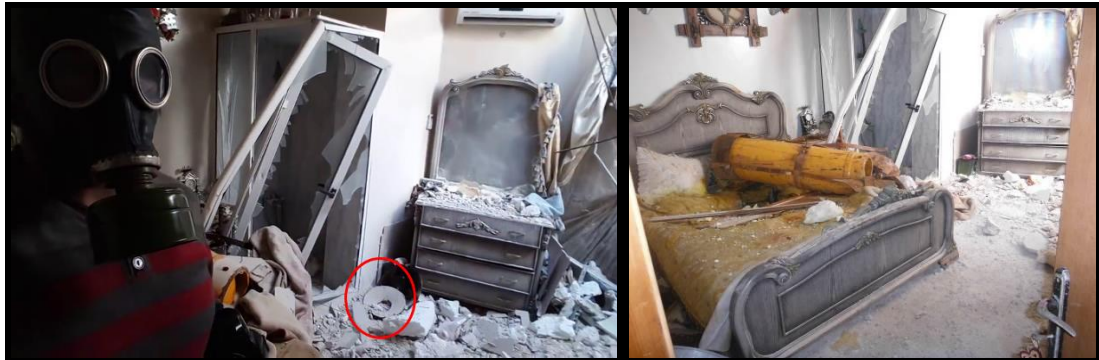
FIGURE A.7.9 FUNNEL CAP

- The bedside lamp on the right side (towards the window) had been moved and was also missing in some photos.
- The FFM team observed a viscous liquid throughout the room, which was not apparent in videos. The same liquid was observed also before the entrance to the apartment and on disposable gloves present at the location (Annex 5).
- The round object similar to the funnel cap found at Location 2 was seen on the open source video.

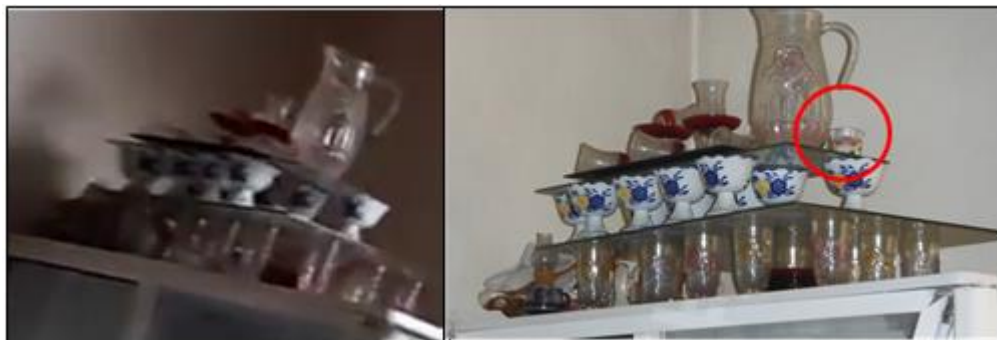
FIGURE A.7.10 OTHER DISCREPANCIES

- Another discrepancy observed while comparing open source videos issued before the FFM visit is related to the cup on the shower cabin. In the initial videos, the cup was not present but on the photos and videos taken by the FFM, the cup is visible.
