OPCW

S/1731/2019
1 March 2019
Original: ENGLISH

NOTE BY THE TECHNICAL SECRETARIAT

**REPORT OF THE FACT-FINDING MISSION REGARDING THE INCIDENT
OF ALLEGED USE OF TOXIC CHEMICALS AS A WEAPON
IN DOUMA, SYRIAN ARAB REPUBLIC, ON 7 APRIL 2018**

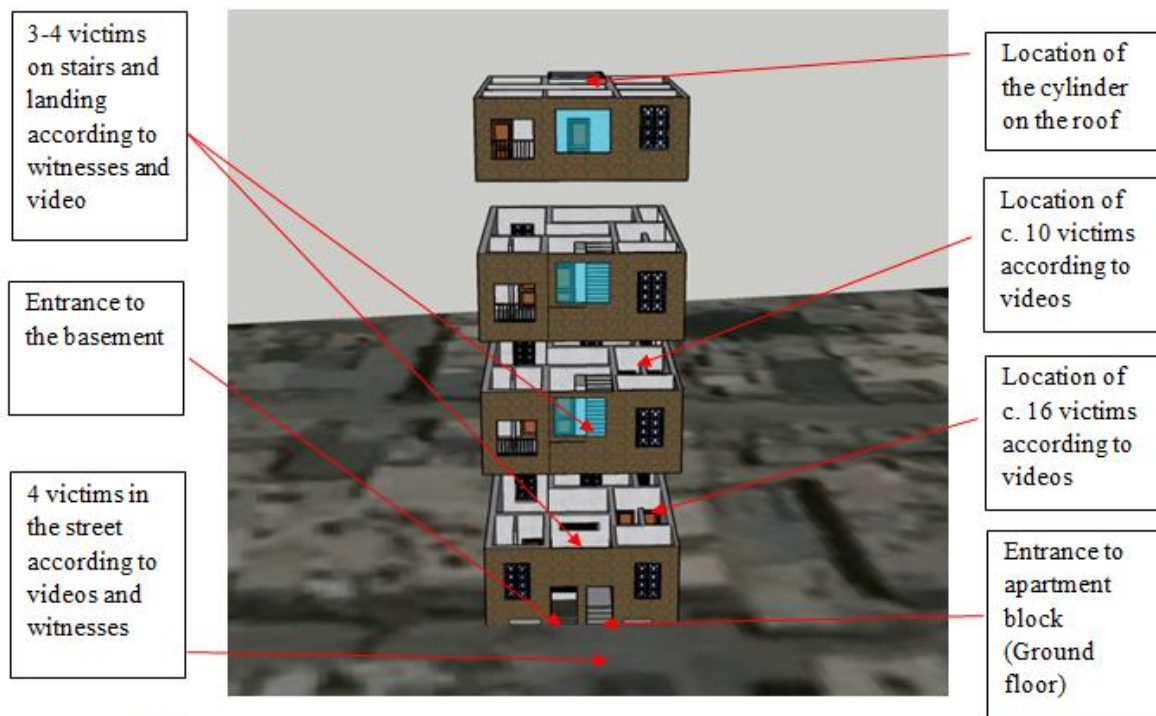
FIGURE 6: 3D LAYOUT OF LOCATION 2 WITH DISTRIBUTION OF ROOMS AND REPORTED LOCATIONS OF ALLEGED VICTIMS

- 8.26 The cylinder was located on the floor of the roof terrace, on the third floor, on the east side of the building, with its nozzle poised over a circular opening in the concrete. The roof terrace where the cylinder was observed corresponds to the ceiling of a room in an apartment on the second floor.
- 8.27 The following three dimensional layouts of the apartment block depict the spatial relationship between the alleged point of impact of the cylinder and the rooms where fallen victims of the alleged chemical attack were located according to the videos provided by witnesses and their accounts.

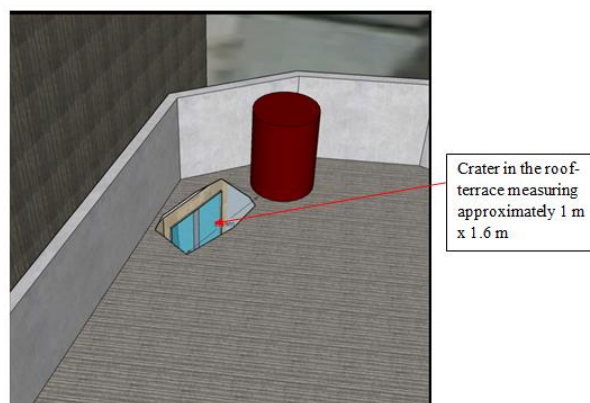
FIGURE 7: COMPUTER-GENERATED VIEW OF THE APERTURE ON THE ROOF TERRACE

- 8.31 The analyses indicated that the structural damage to the rebar-reinforced concrete terrace at Location 2 was caused by an impacting object with a geometrically symmetric shape and sufficient kinetic energy to cause the observed damage. The analyses indicate that the damage observed on the cylinder found on the roof terrace, the aperture, the balcony, the surrounding rooms, and the rooms underneath and the structure above, is consistent with the creation of the aperture observed in the terrace by the cylinder found in that location.

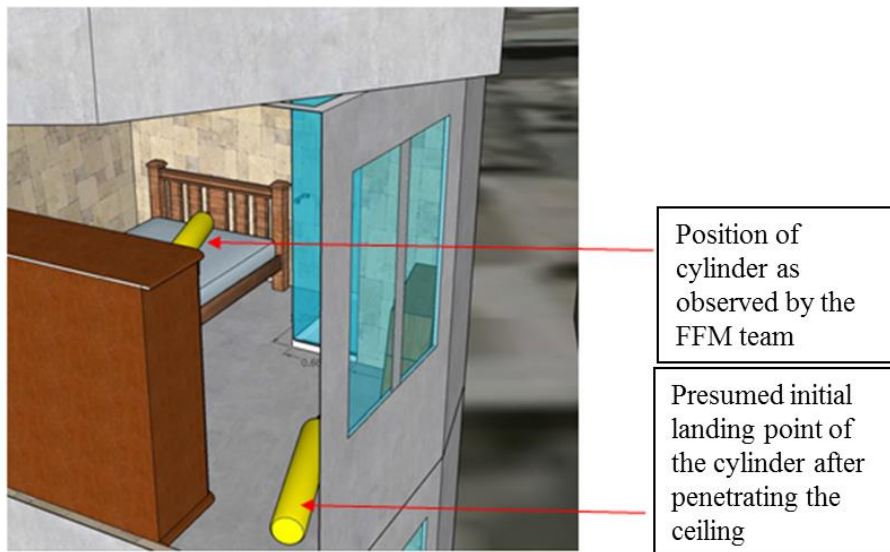
FIGURE 11: VIEW OF THE BEDROOM AND CYLINDER POSITION

- 8.33 From what the team observed, there did not appear to be any leakage from the cylinder at the time the team visited the location. The team noted that a slat of wood was lying under the cylinder on the bed, part of which was taken as a sample. The slat of wood was damp and softened. No chlorine gas was detected in the room by the detection equipment used by the team. The laboratory analysis showed that the wood sample had the highest content of chlorinated organic compounds of all wood samples taken.

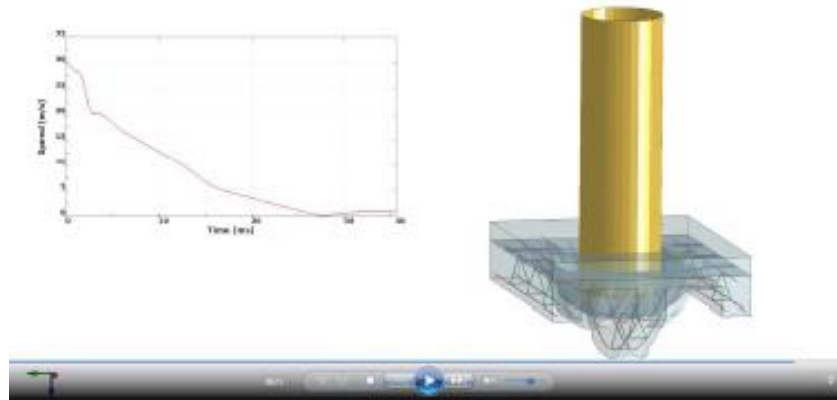
FIGURE A.6.7(a) MODULATION OF CYLINDER IMPACT ON BALCONY CEILING

²¹ The angle shown in figures A.6.6, A.6.7 (a) to (c) are indicative only and not representing actual impact angle.

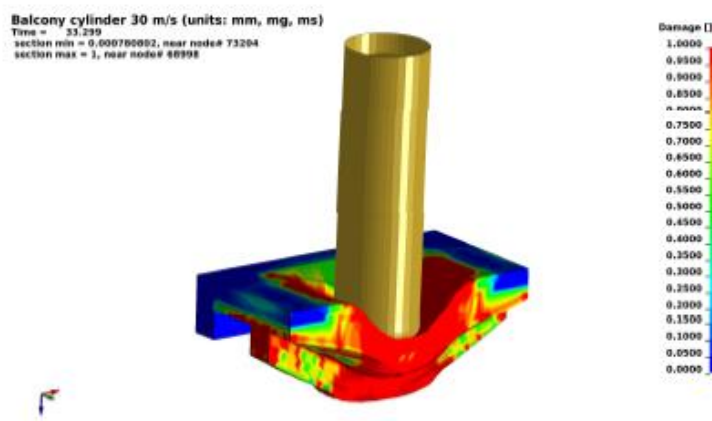
FIGURE A.6.7(b) DAMAGE ON THE CEILING IN THE CASE OF LOW SPEED IMPACT

Red colour indicates zone of complete disintegration

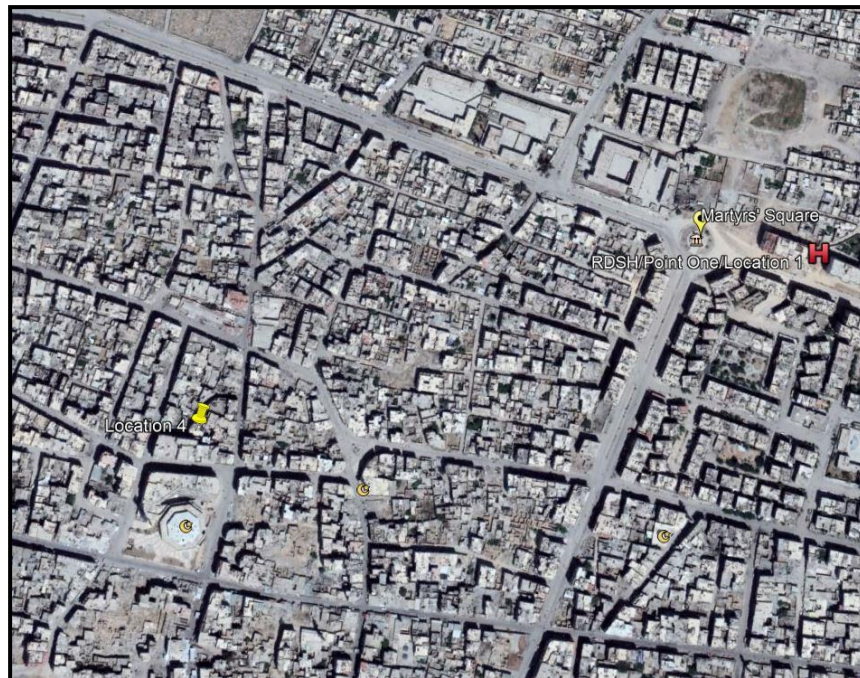
FIGURE A.7.1 THE AREA IN WHICH THE CYLINDER WAS OBSERVED IN A BEDROOM IN A TOP FLOOR APARTMENT

- 8.16 At Location 4, the team observed visible signs of corrosion on the metallic objects present in the apartment, such as the chandelier, the bedside lamps, pipes, and drawer handles, in addition to the cylinder itself, the valve and the harness. The corrosion of all metal objects is a clear indication of their exposure to a corrosive substance. At Location 2, some corroded objects were also observed. However, the FFM team was unable to establish whether the corrosion was related to a corrosive substance or to natural factors. At both locations, there were no visible signs of a bleach agent or discoloration due to contact with a bleach agent.

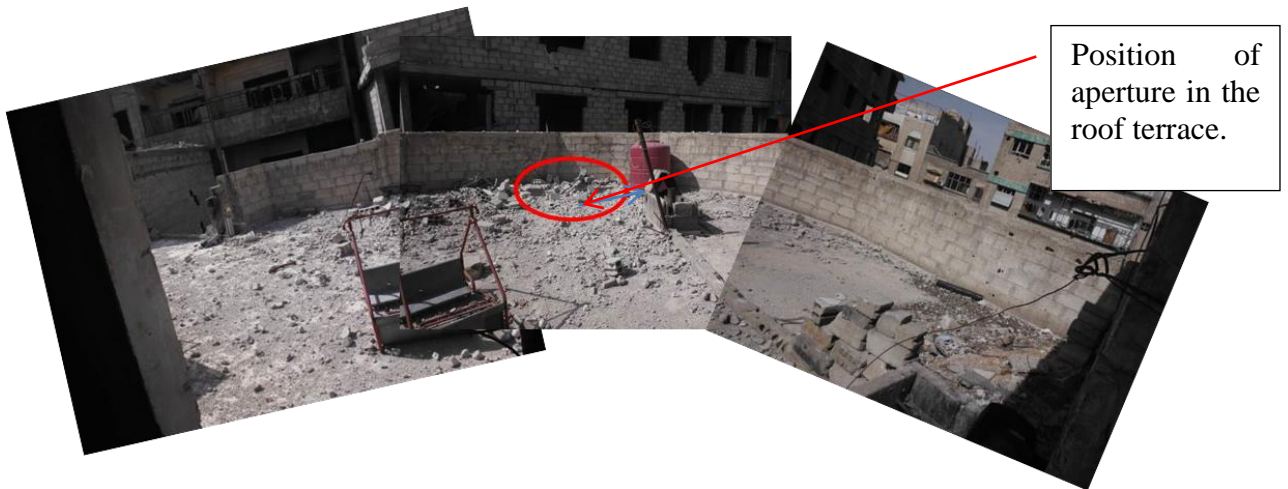
FIGURE A.7.3 ROOF OF LOCATION 4

Area shaded in red marks the roof of Location 4

Position of aperture in the roof terrace.

The aperture was located close to a surrounding wall and next to the water tank with approximate dimensions of 166 x 105 cm. The distance from the adjacent building varies between 230 cm and 250 cm.

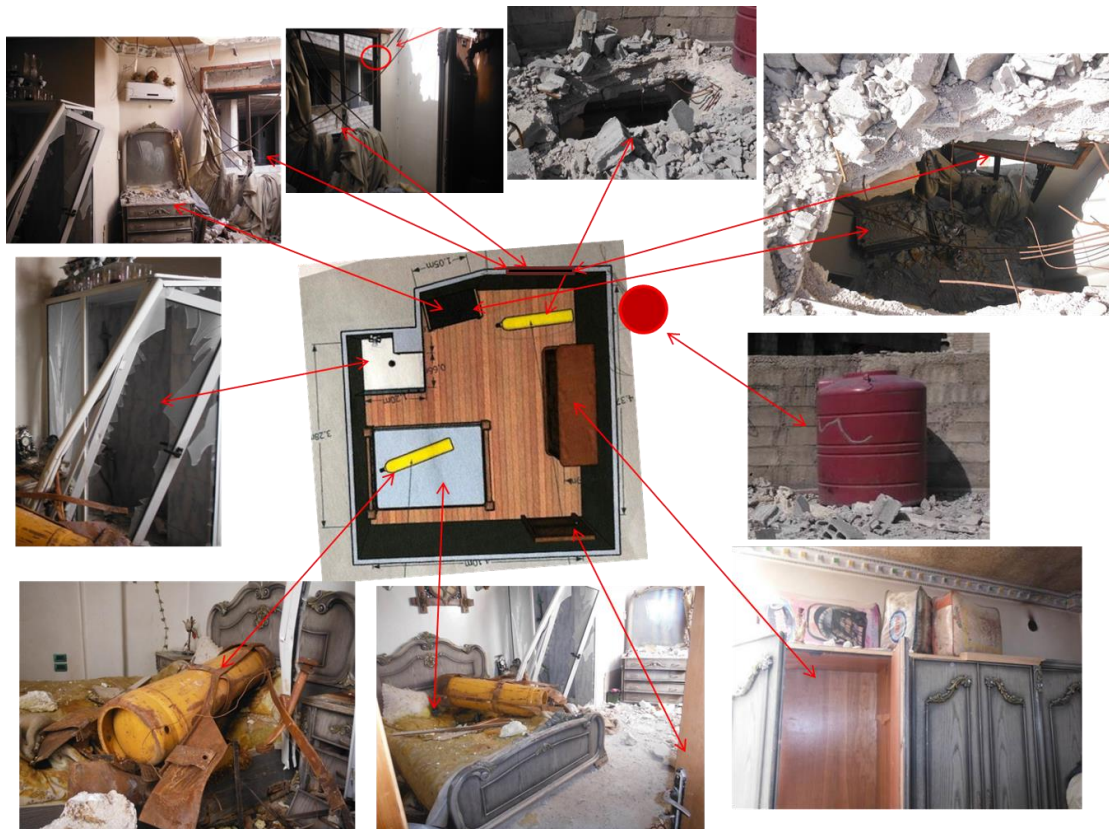
FIGURE A.7.6 SCALE REPRESENTATION OF LAYOUT OF LOCATION 4 ("CYLINDER IN A BEDROOM")

Considering the proximity of the water tank, the neighbouring buildings, and the surrounding wall adjacent to the hole in the roof, it was concluded that the cylinder impacted the roof as shown in Figure A.7.6. From the shape of the crater and damage on the cylinder, it is likely that the cylinder landed parallel to the ground creating a crater with dimensions of approximately 166 x 105 cm, which is in keeping with the dimensions of cylinder of 140 x 35 cm. It should be noted that the cylinder had an additional structure attached to the body, which is still in line with the dimensions of the crater. The damage observed on site by the FFM team and the possible trajectory of the cylinder based on observed damage and numerical calculations are represented in Figure A.7.7.

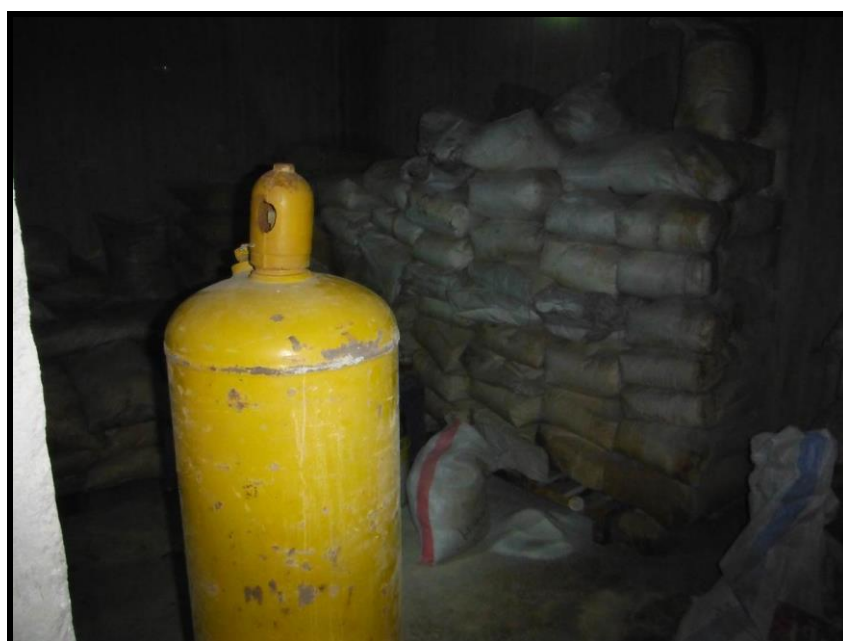
FIGURE A.8.2 CYLINDER OBSERVED BY THE FFM TEAM AT THE WAREHOUSE

7. Although the team confirmed the presence of a yellow cylinder in the warehouse, reported in Note Verbale of the Syrian Arab Republic (Annex 10, point 2) as a chlorine cylinder, due to safety reasons (risk involved in manipulating the valve of the cylinder, see Figure A.8.2) it was not feasible to verify or sample the contents. There were differences in this cylinder compared to those witnessed at Locations 2 and 4. It should be noted that the cylinder was present in its original state and had not been altered. Chlorine gas is generally not a common chlorinating agent in the production of chemical weapons agents, except when used in conjunction with phosphorous trichloride, which was not present. Subsequently, the presence of a cylinder reported as containing chlorine gas is not indicative of the production of explosives.

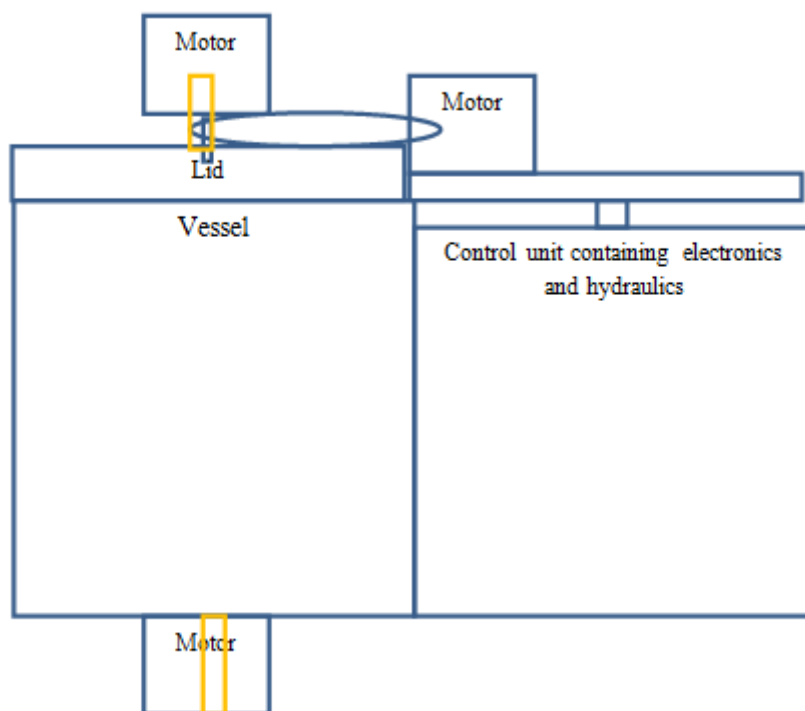
FIGURE A.8.5 SCHEME OF MIXING VESSEL

12. The mixing vessel was of a specific design, and the team considered that these design features did not make the unit particularly suited for chemical synthesis of toxic or any other chemicals. The installation appeared to be a heating and kneading unit that could be used for filling ammunition with liquid explosives or for mixing explosives with additives. Examples would include mixing of TNT with aluminium to produce tritonal, and mixing of RDX with liquid rubber for the production of plastic explosives.
